**SUMMARY REPORT FOR THE
TORCH LAKE AREA ASSESSMENT
TORCH LAKE NPL SITE
AND SURROUNDING AREAS
KEWEENAW PENINSULA, MICHIGAN**

Date Prepared	December 13, 2007
TDD Number	S05-0002-0708-020
Contract Number	EP-S5-06-04
Document Control Number	274-2A-ABDT
START Project Manager	Daniel M. Capone
Telephone No.	(906) 482-3085
U.S. EPA On-Scene Coordinator	Brian Kelly

EXECUTIVE SUMMARY

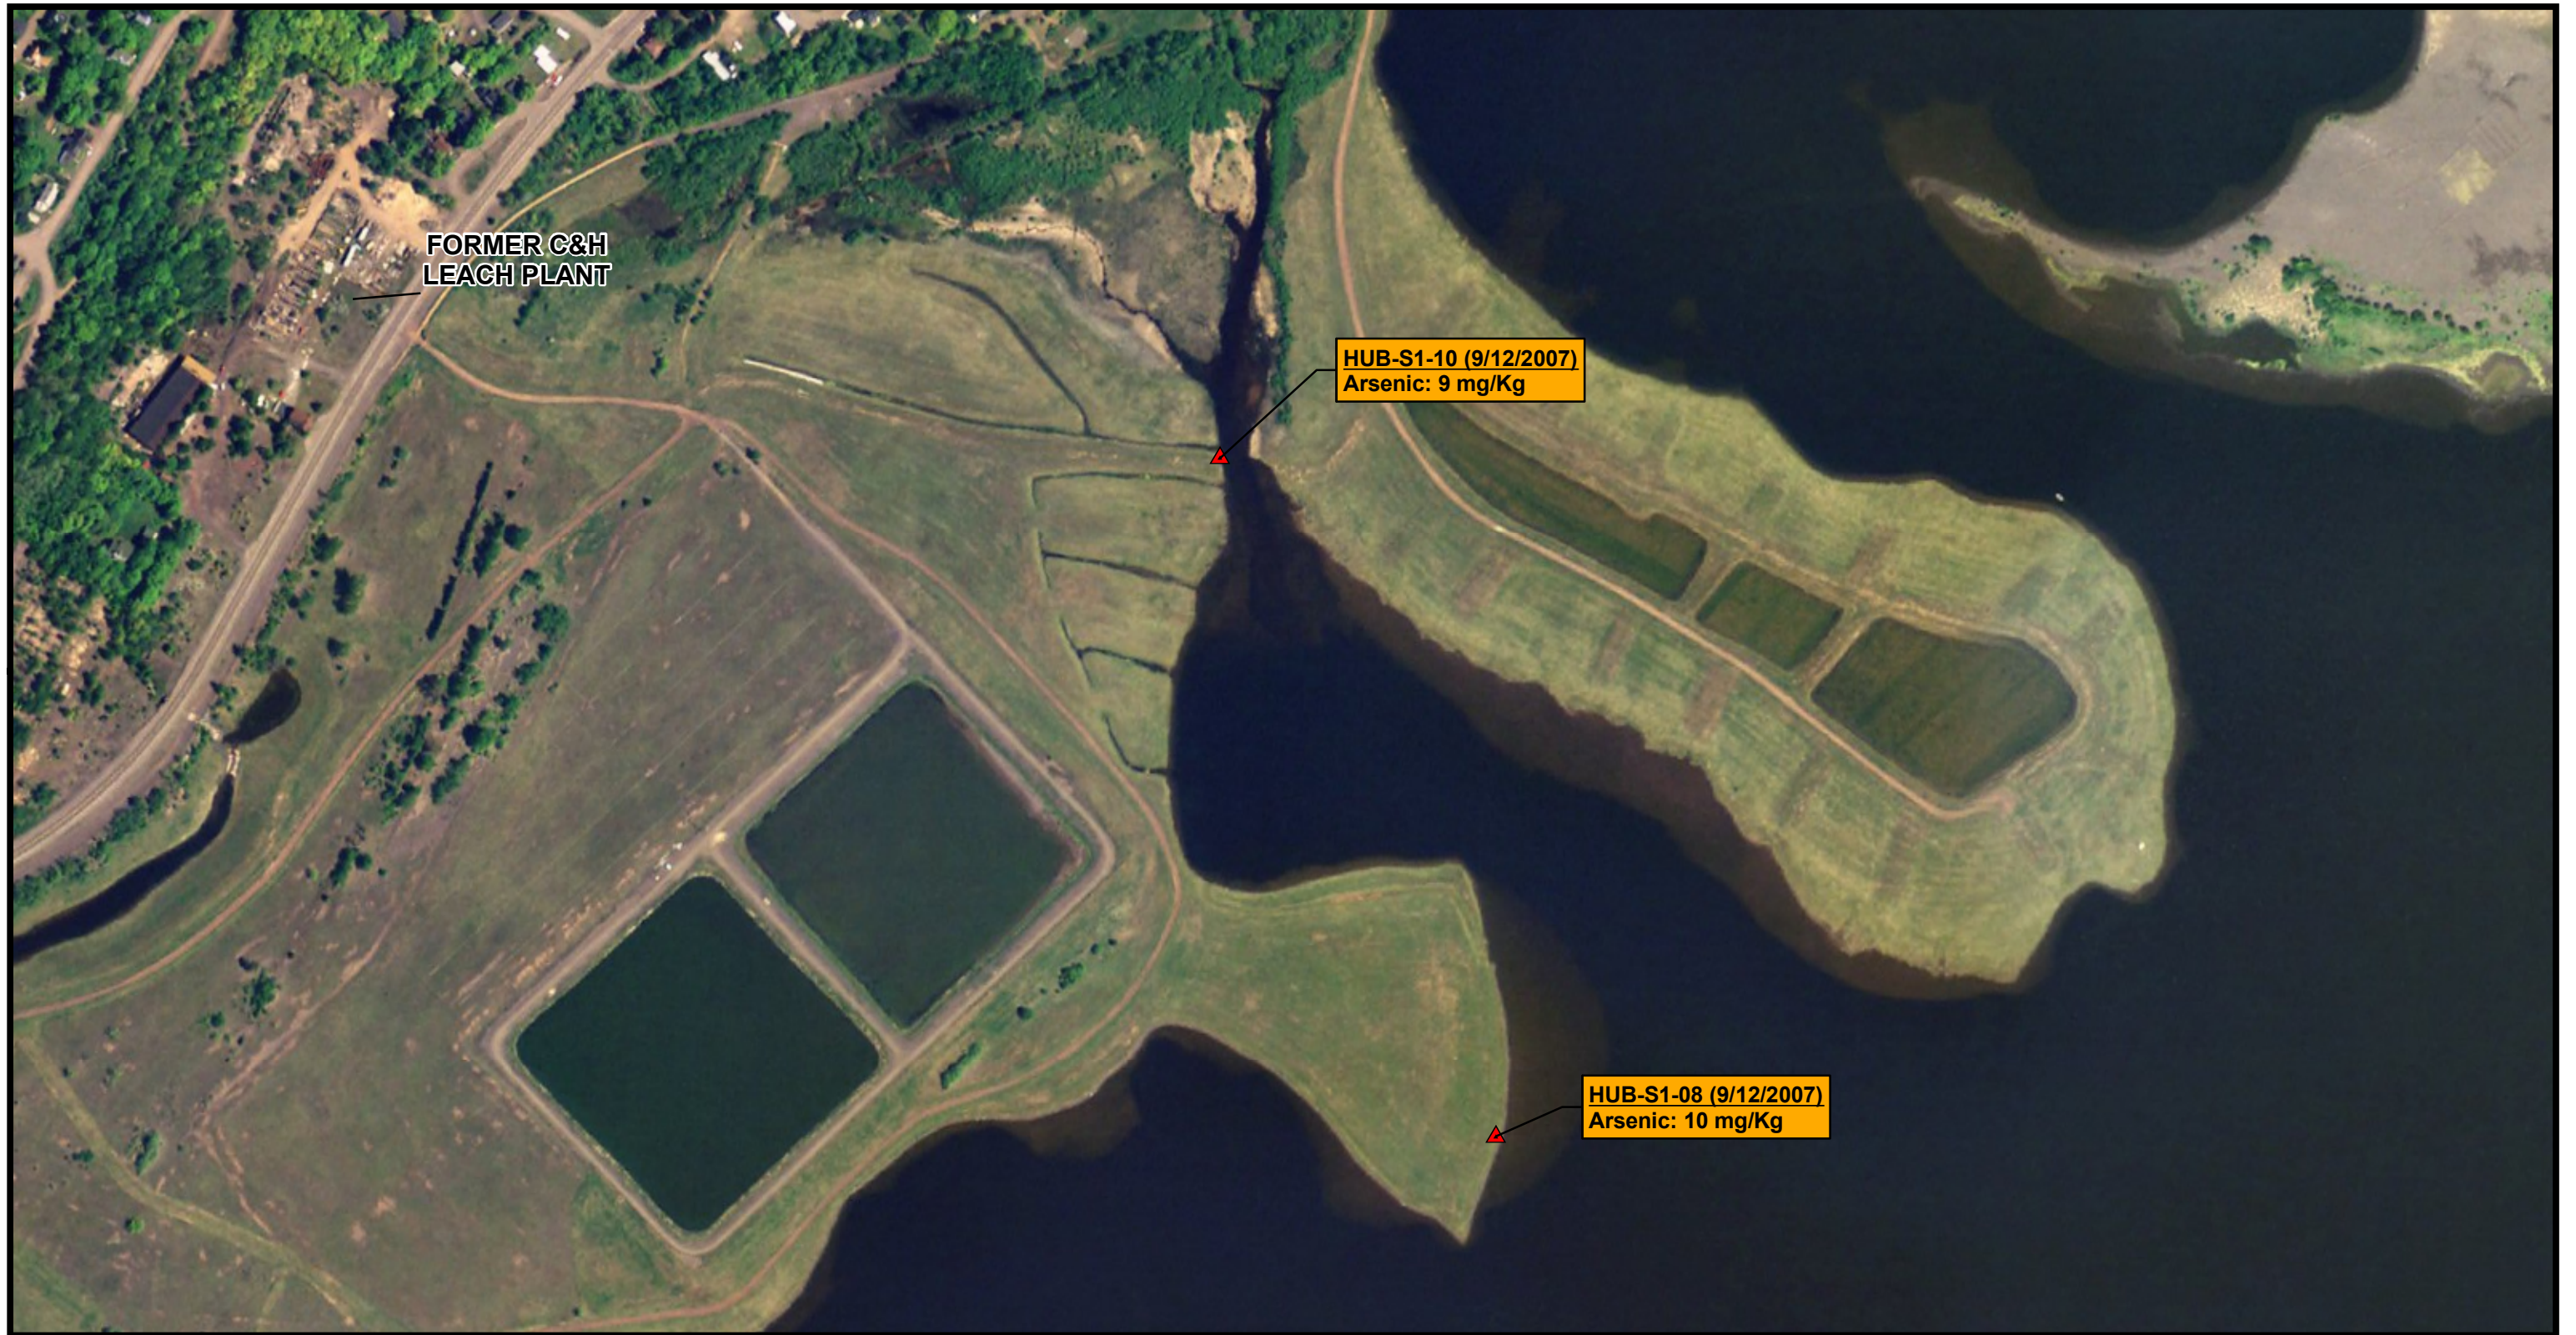
Figure 5a

AOI No. 19
SITE FEATURES AND XRF LOCATIONS
TORCH LAKE AREA ASSESSMENT
KEWEENAW PENINSULA, MICHIGAN
October 2007

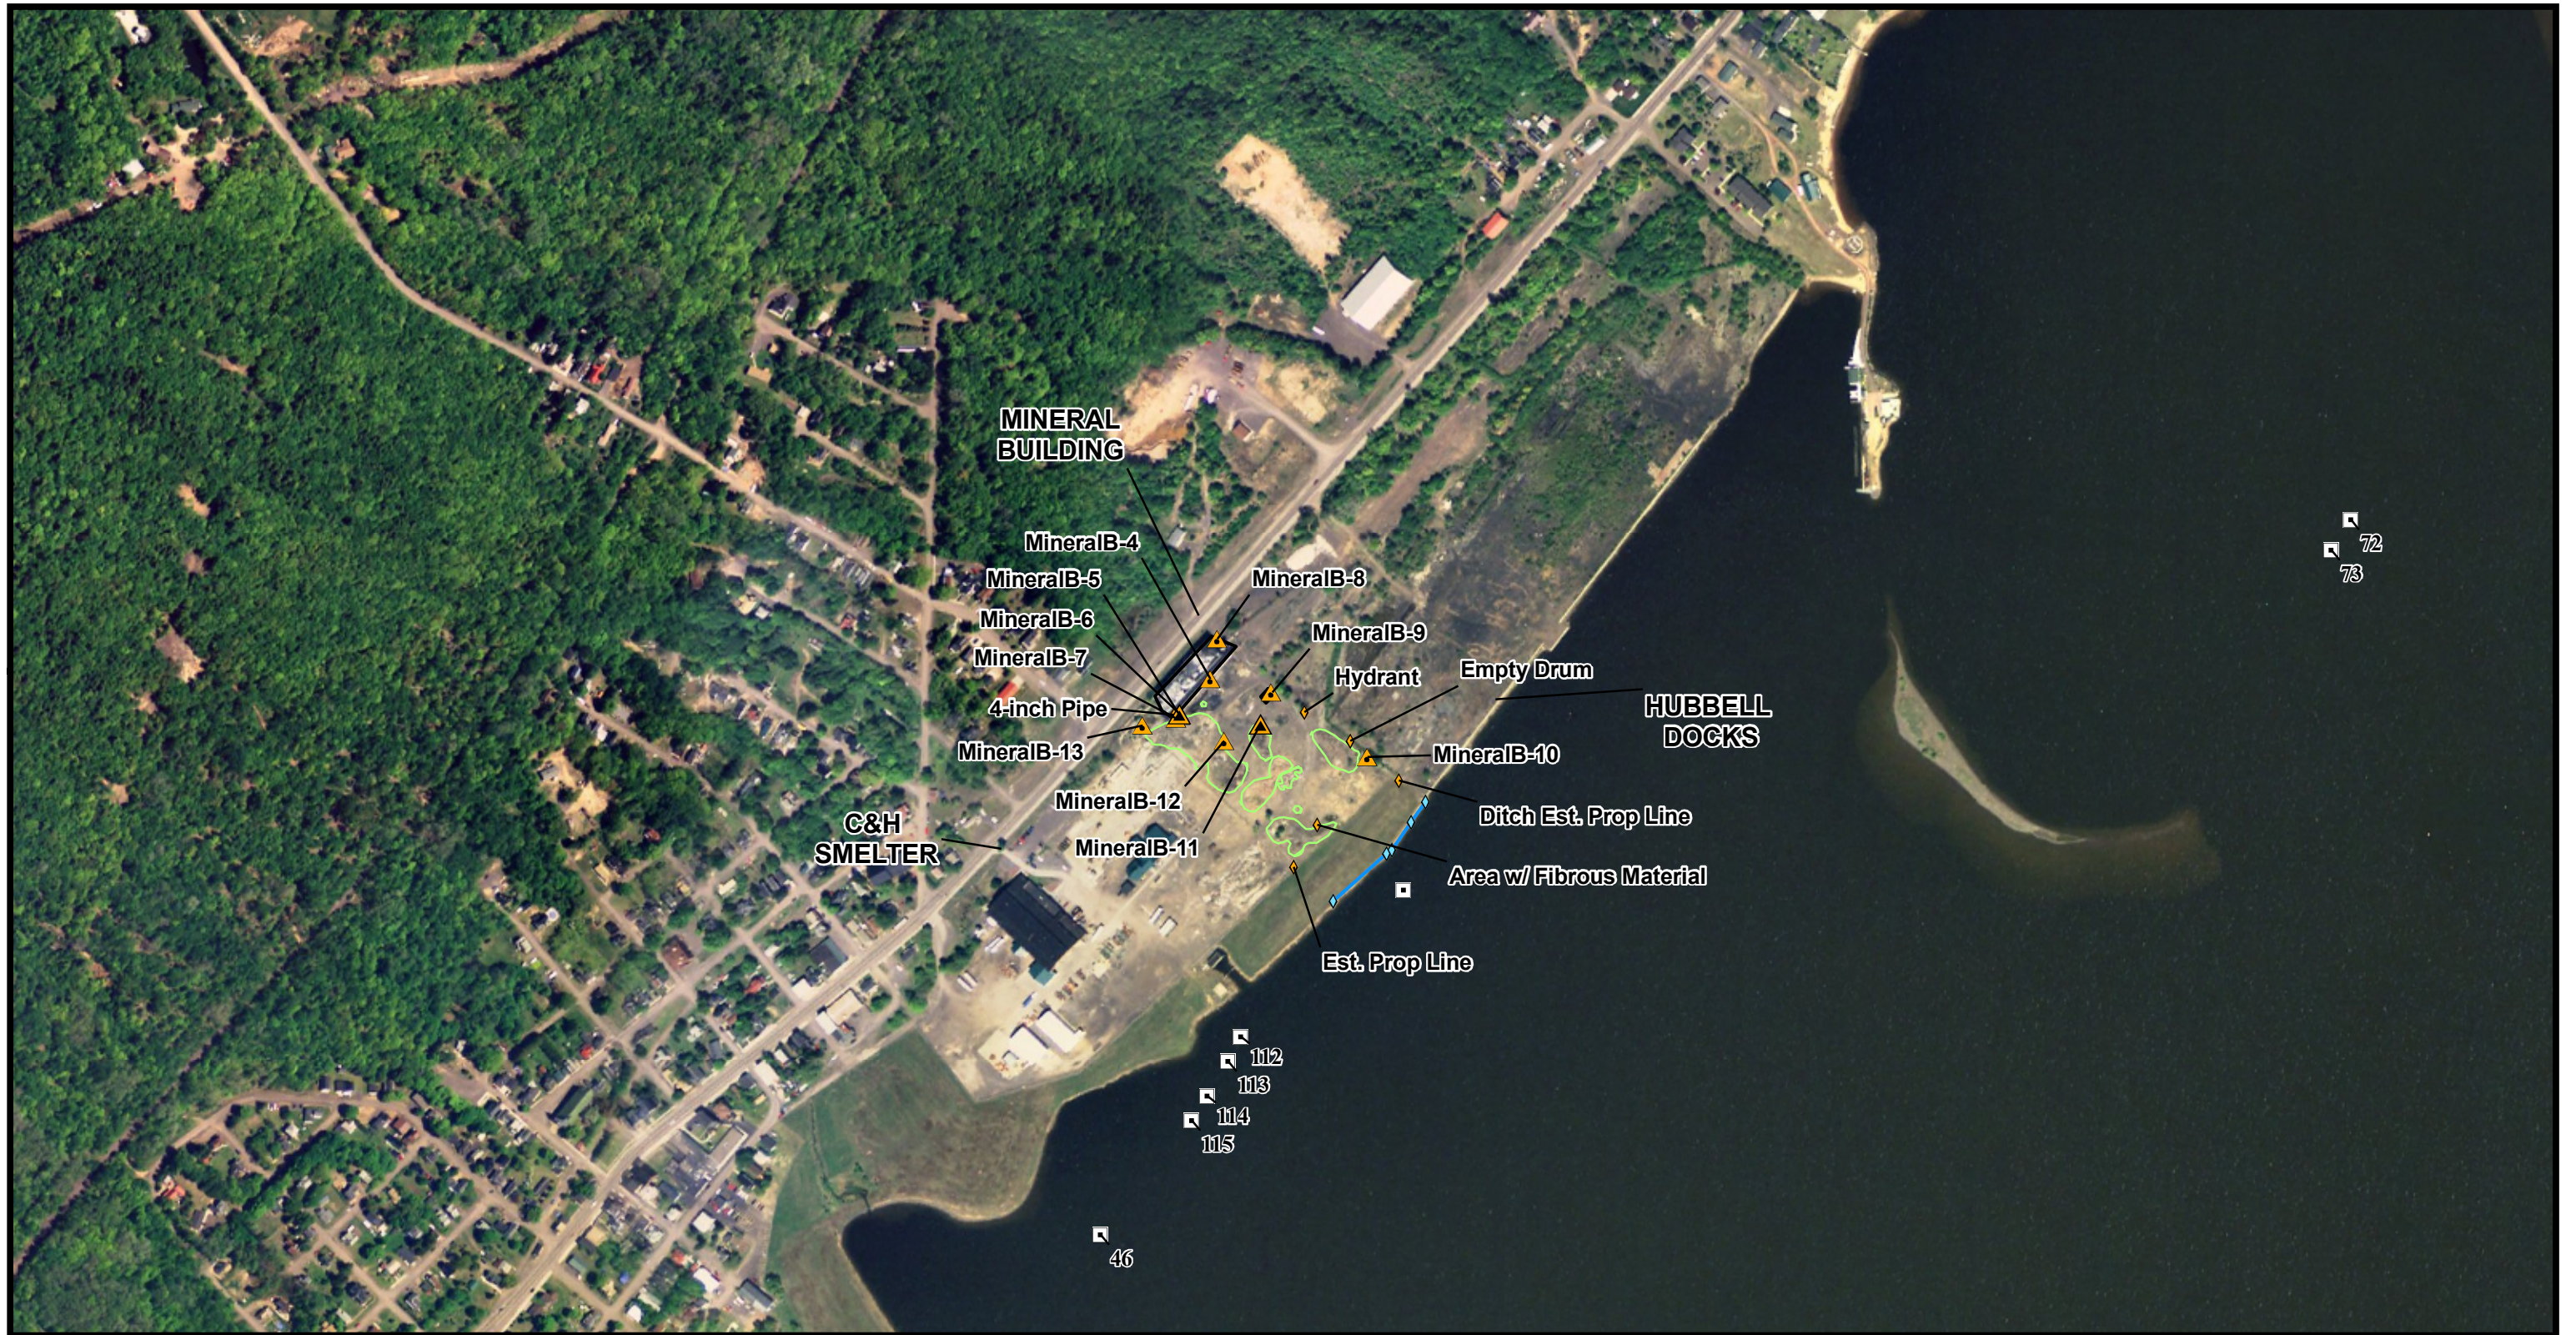
Figure 6

The Tamarack City Stamp Mill (AOI 20) is located in Tamarack City, Houghton County, Michigan. Specifically, the site is located in Section 13 of Osceola Township, Township 55 North and Range 33 West (**Figure 6**). AOI 20 is bounded by Highway M-26 to the north/northwest, a park to the west/southwest, Spruce Road to the south and east, Sixth Street to the northeast, and is surrounded by residential property. Torch Lake is located to the southeast and east of AOI 20.

There are two areas associated with AOI 21: Hubbell Beach and the Hubbell Slag Dump (**Figure 6**). The Hubbell Beach area, which is part of a Township Park that includes a boat launch, docks, and a playground, was not part of the Torch Lake NPL Site and therefore not part of previous U.S. EPA remedial efforts. The area constitutes a new AOI based on MDEQ reports of industrial and household dumping on the lake bottom adjacent to the beach, and direct discharge of residential sewage from local homes via piping to the northeast lobe of the stamp sand beach. The Hubbell Slag Dump and surrounding area, located adjacent to the Hubbell Beach, was addressed during previous U.S. EPA remedial efforts via the placement of a vegetative cover.

Three locations on the shoreline were screened with an Innov-X 4000 XP/Auto XRF: the black staining on the beach, a pile of soil near the beach, and exposed stamp sands flowing out from under the cap at the former slag dump (HubbellB-2, HubbellB-3, and HubbellB-4, respectively) (**Figure 6**). No metals concentrations exceeded RDCC criteria (**Table 7**).

AOI Nos. 20 and 21
SITE FEATURES AND XRF LOCATIONS
TORCH LAKE AREA ASSESSMENT
KEWEENAW PENINSULA, MICHIGAN
October 2007

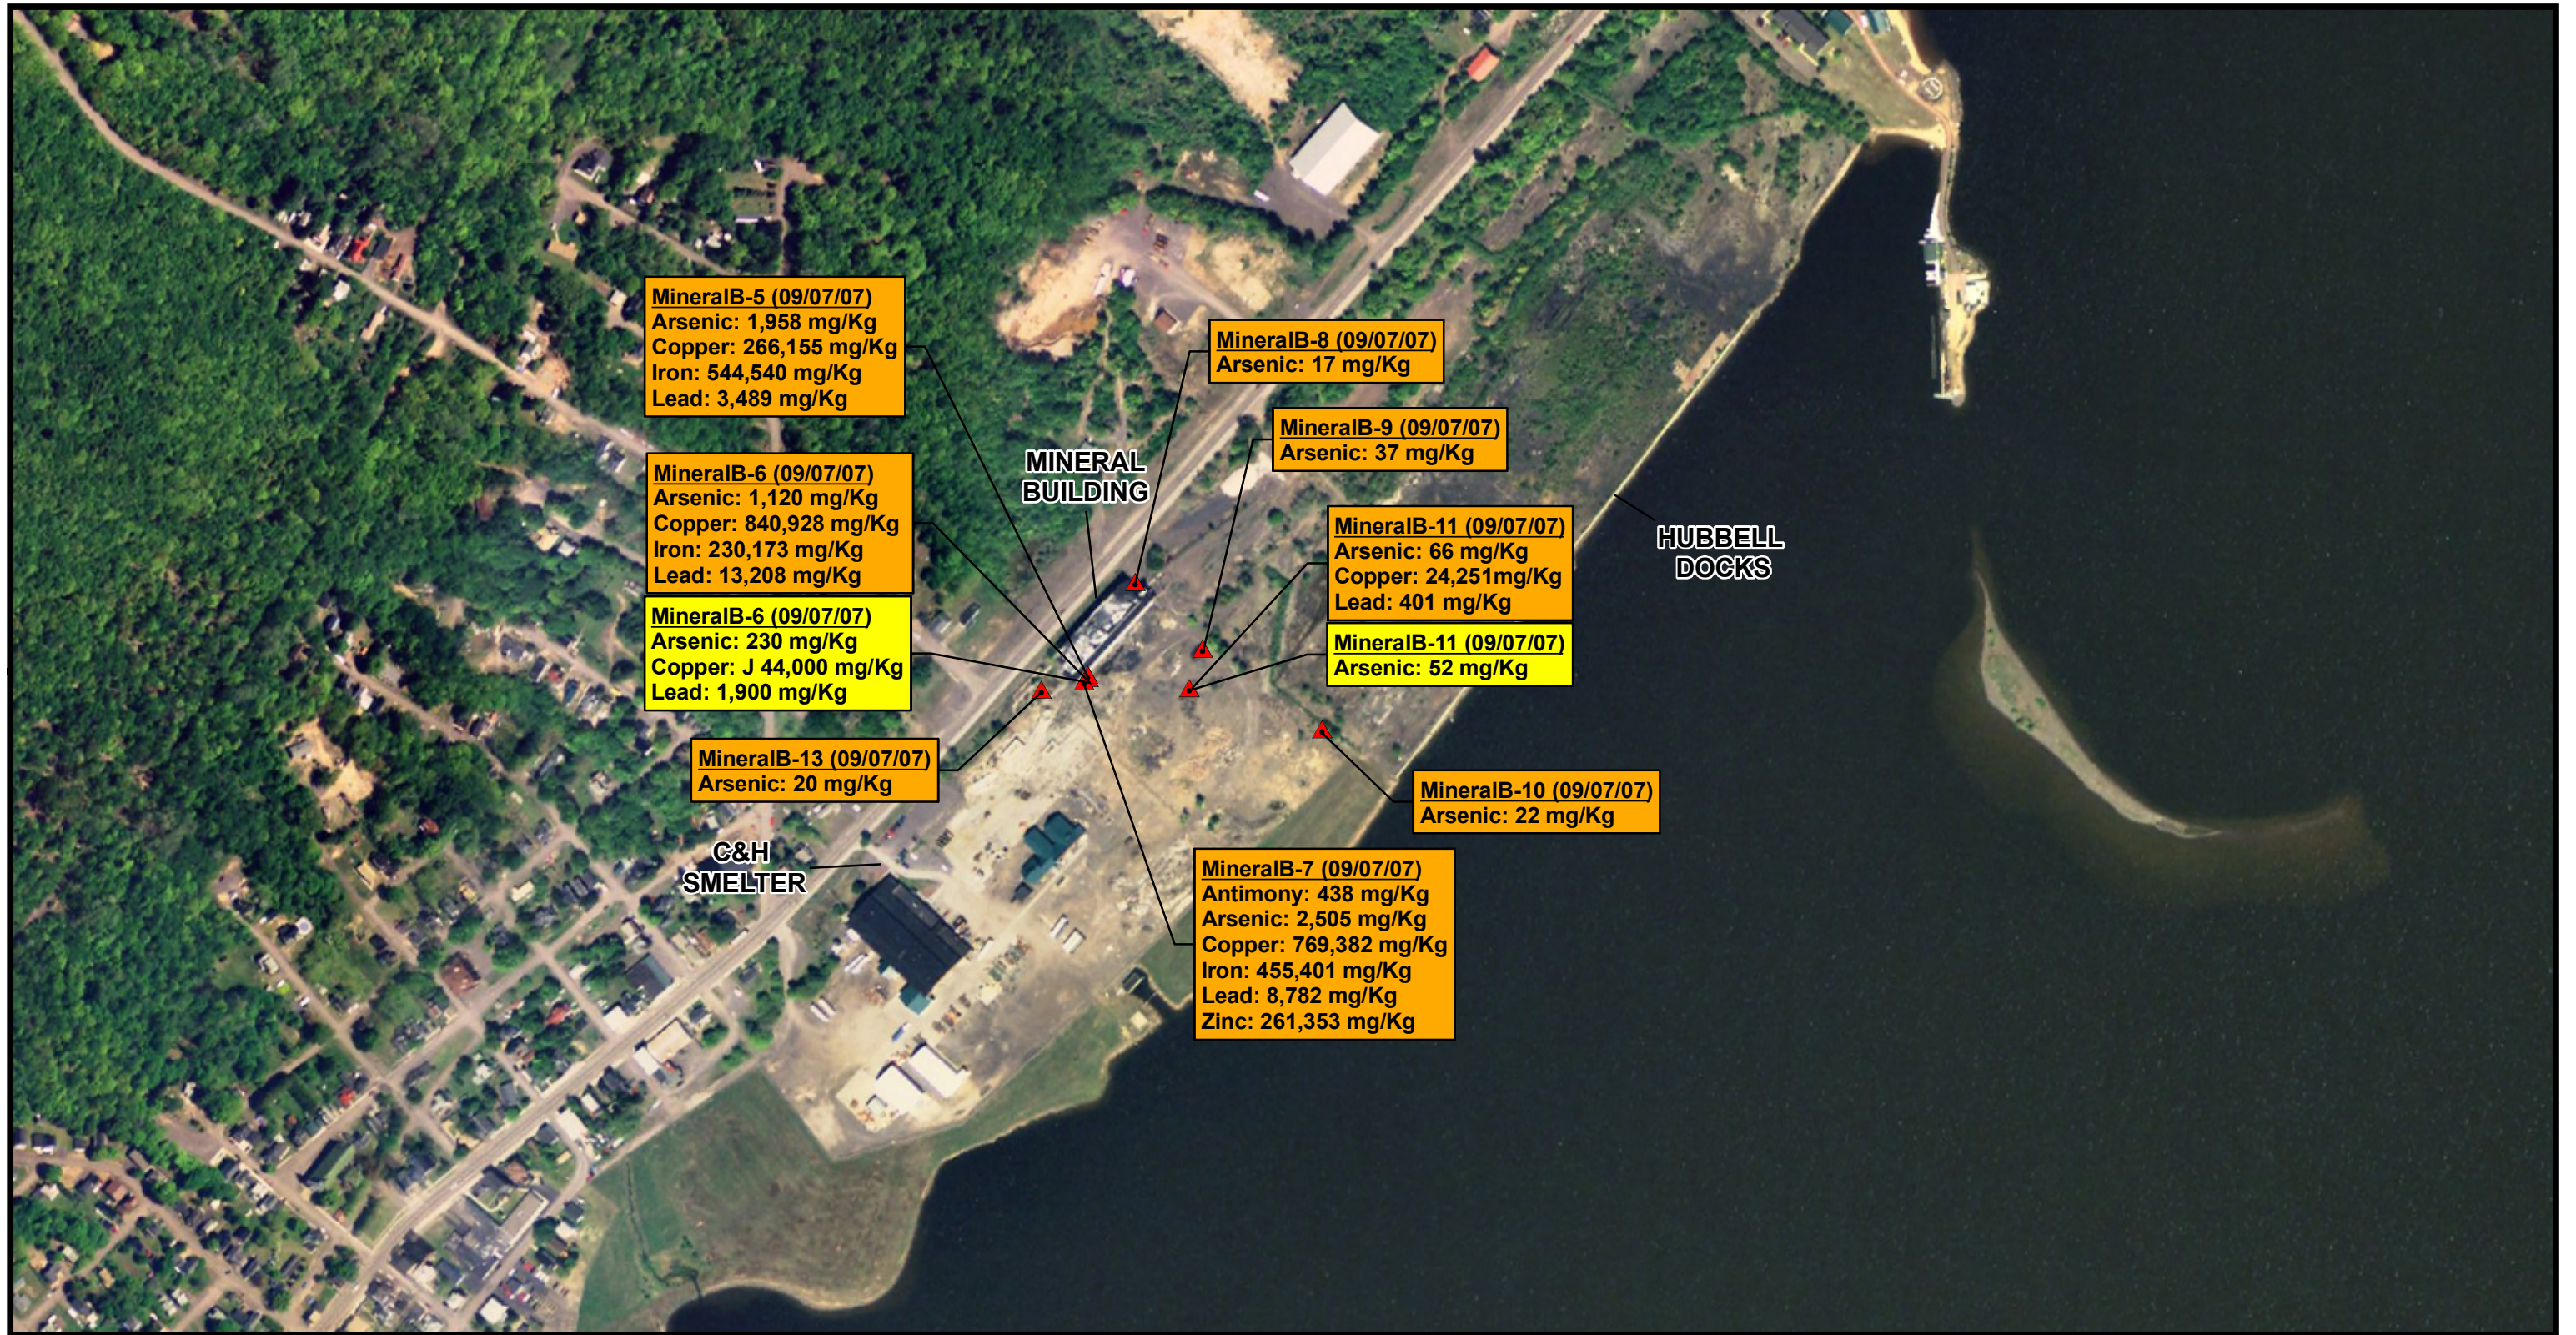
AOI No. 22
SITE FEATURES AND XRF LOCATIONS
TORCH LAKE AREA ASSESSMENT
KEWEENAW PENINSULA, MICHIGAN
October 2007

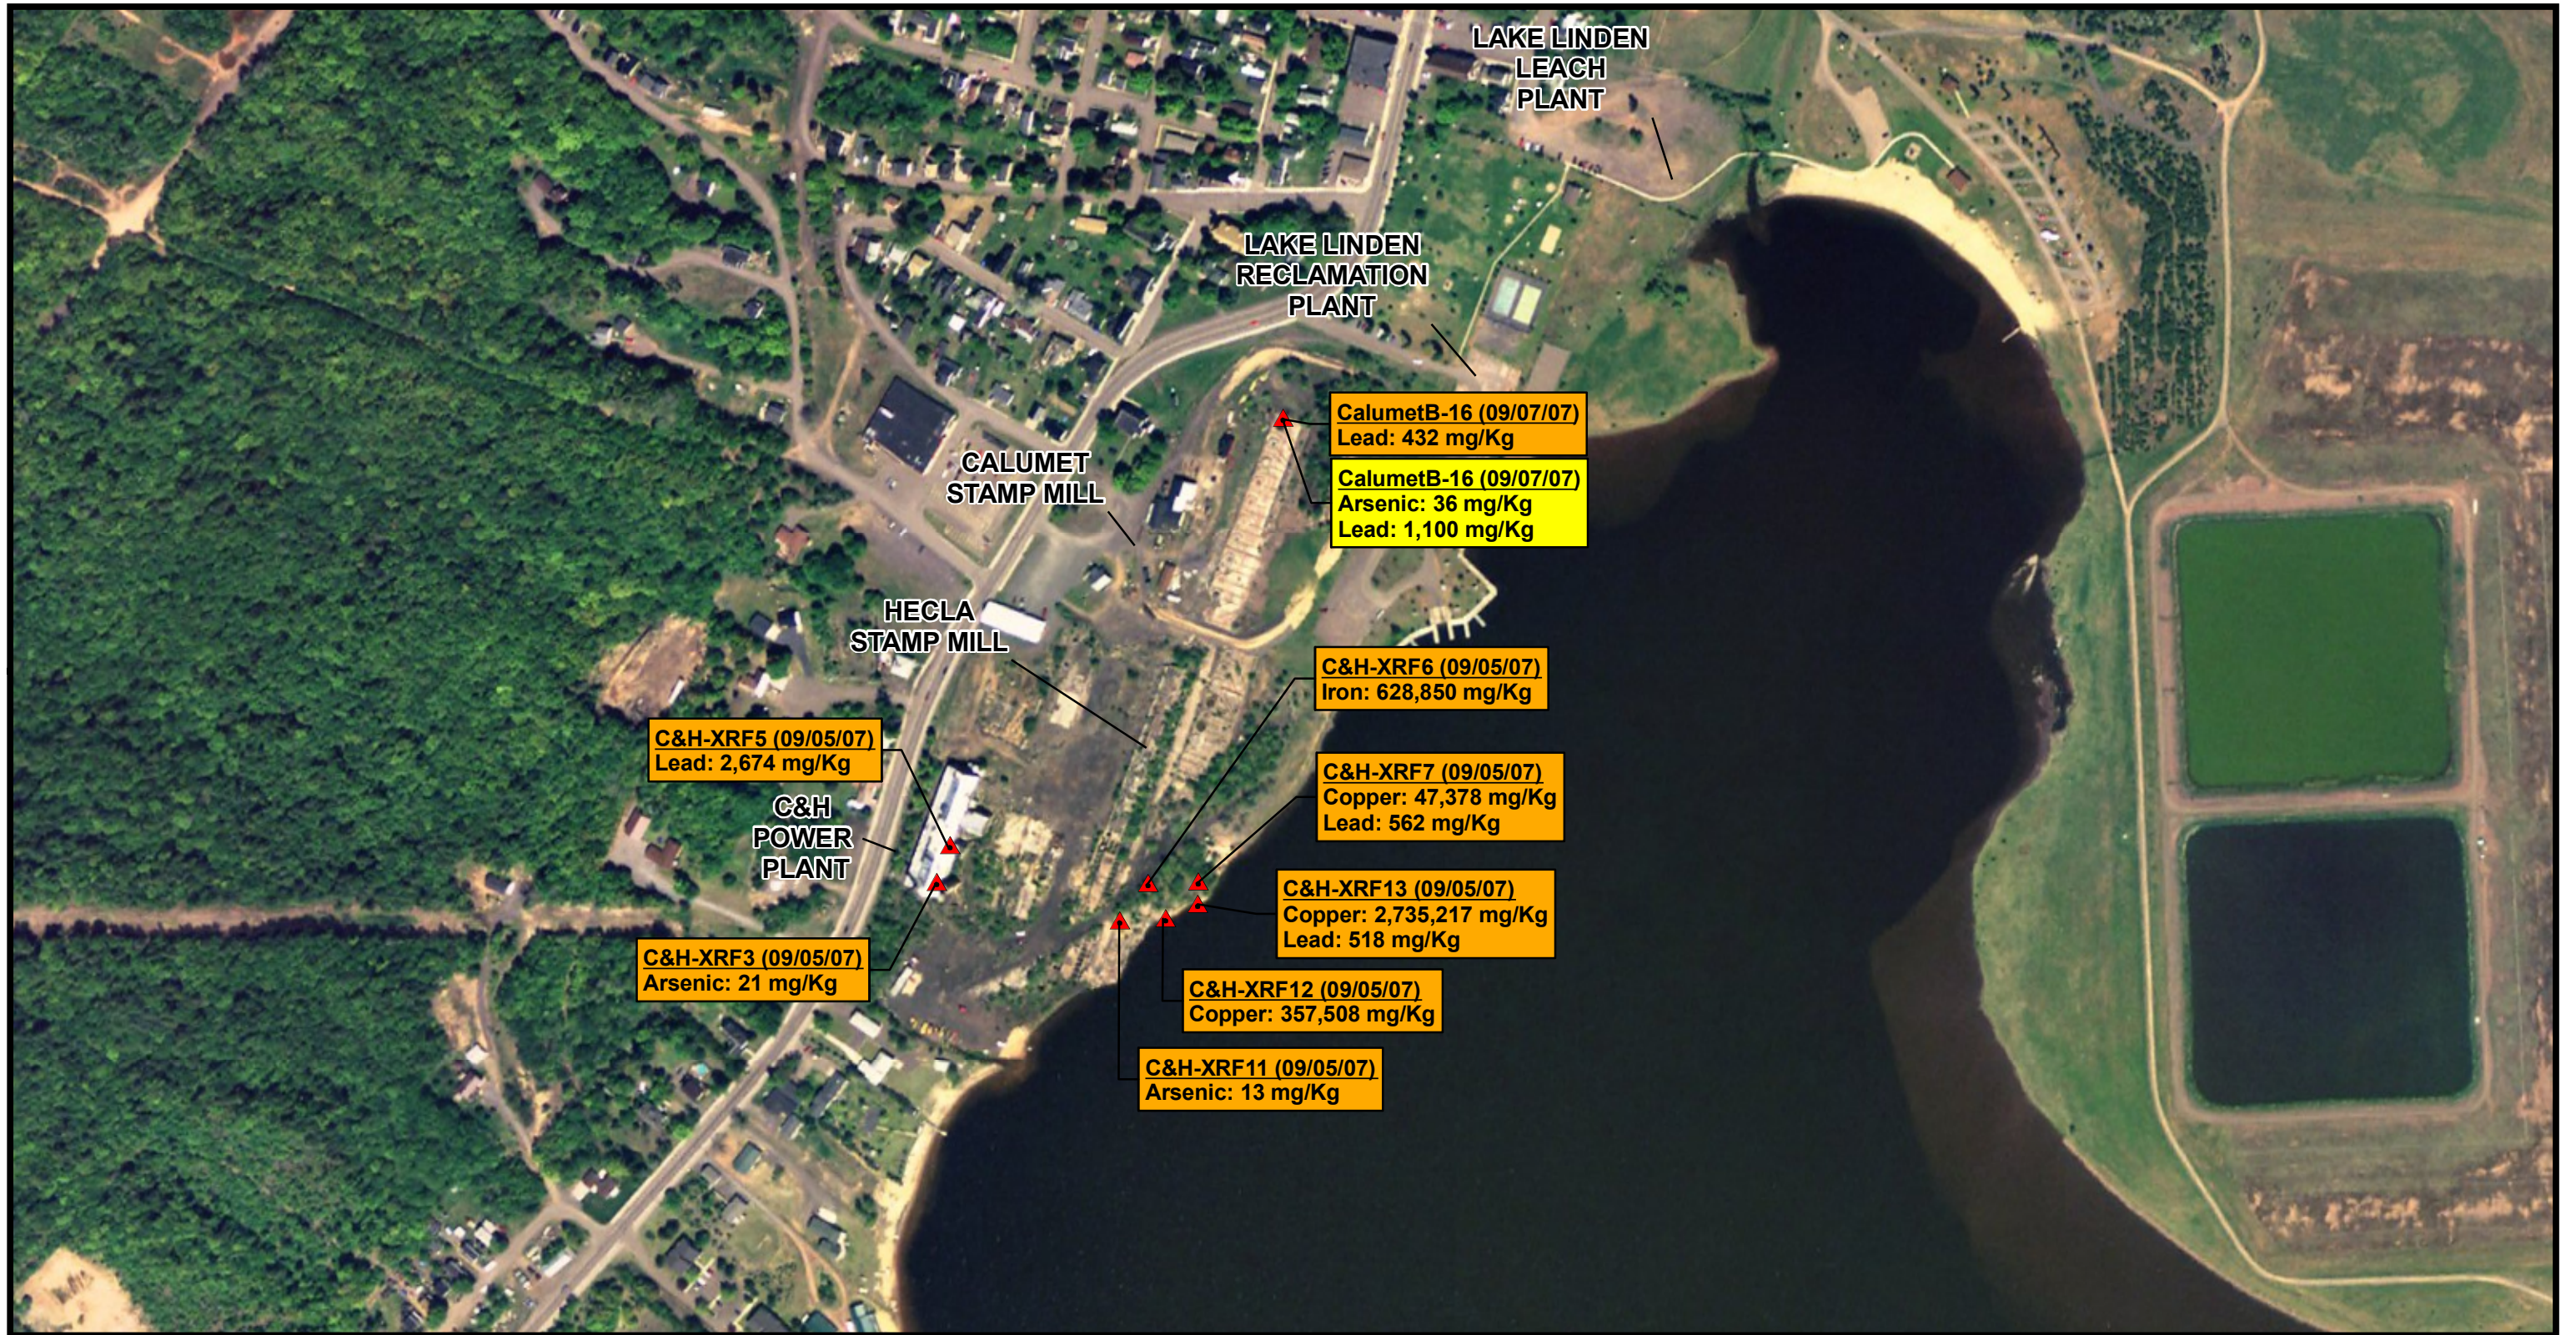
Figure 8a

(**Figure 8a**). The LLRP is a publicly owned recreational area located at the north end of Torch Lake at M-26, in a delisted portion of the Torch lake NPL Site. The LLRP and the Houghton County Historical Museum encompass the former locations of the Lake Linden Reclamation Plant, the Lake Linden Leach Plant, the Calumet Stamp Mill, and the Municipal Dump.

The C&H Power Plant AOI, also known as the Former Calumet & Hecla Power Plant, is a 14-acre property that contains a dilapidated power plant building (C&H Power Plant), exposed foundation materials (Former Hecla Stamp Mill), debris, empty drums, ASTs, slag, and exposed stamp sands (**Figure 8a**). The property was part of a large copper ore processing facility that was in operation for more than a century.

AOI Nos. 12 and 23
SITE FEATURES AND XRF LOCATIONS
TORCH LAKE AREA ASSESSMENT
KEWEENAW PENINSULA, MICHIGAN
October 2007

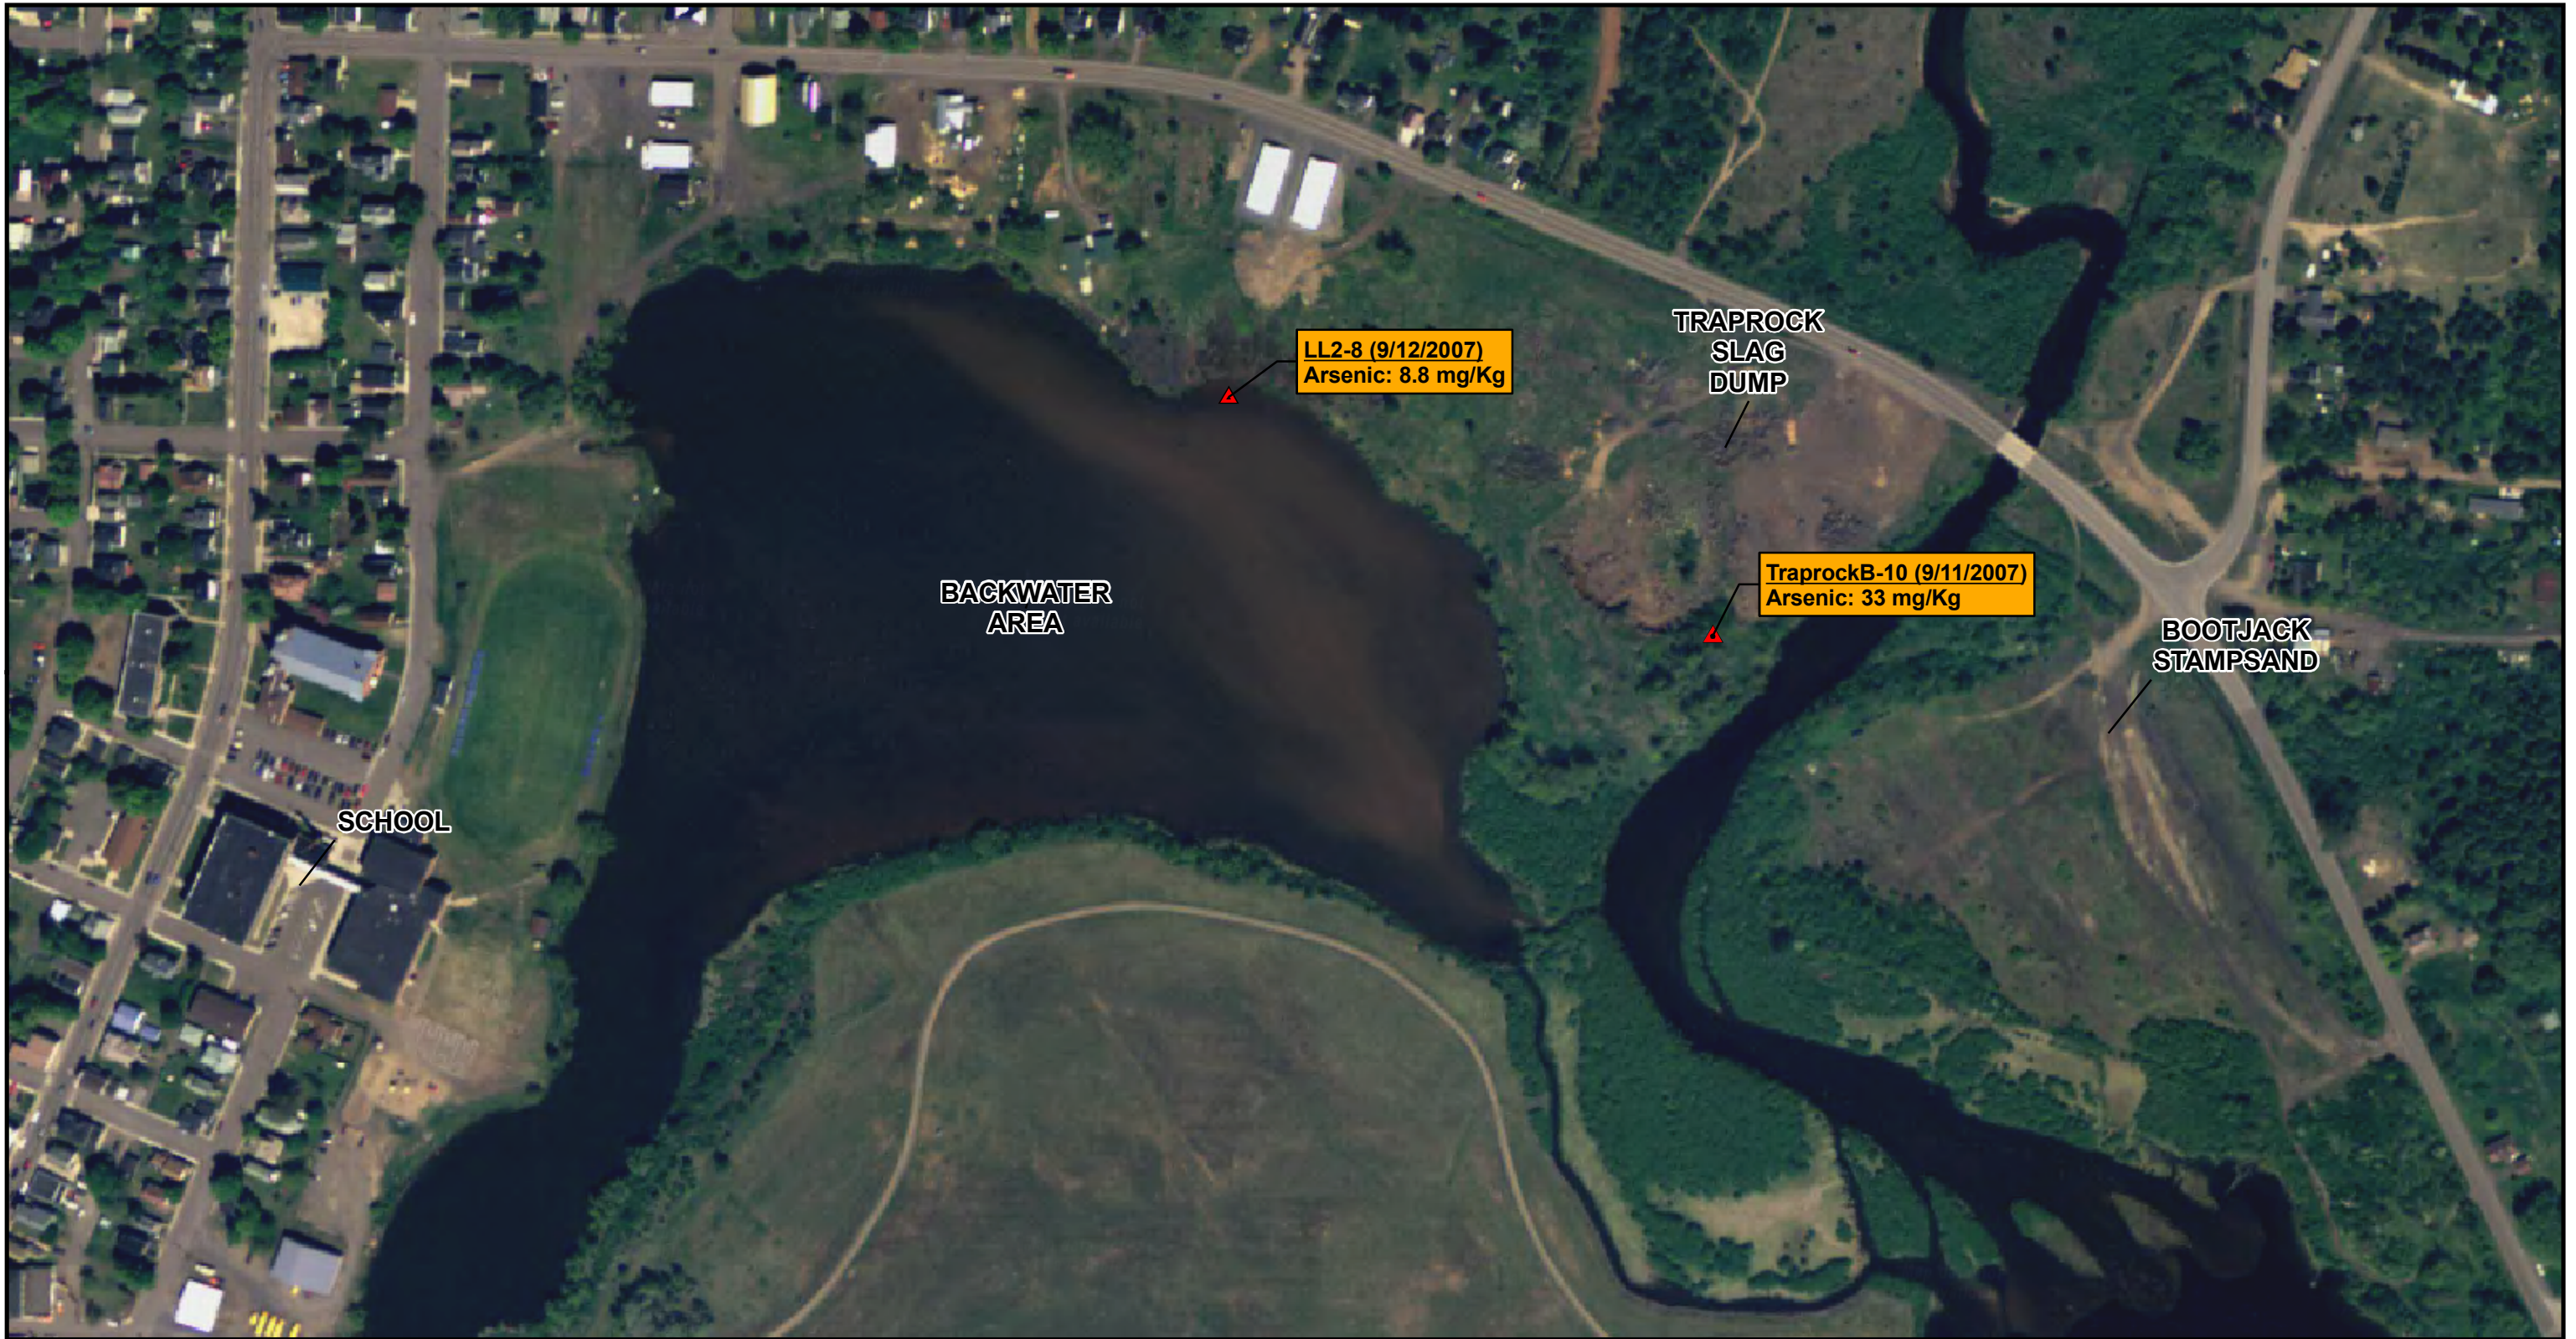
Figure 9a

of the Torch Lake NPL Site and therefore not part of previous U.S. EPA remedial efforts (**Figure 9a**).

The Traprock Slag Dump is a new AOI and includes open areas with slag boulders and an area, reportedly, previously used for transformer disposal. These areas were not part of the Torch Lake NPL Site and therefore not part of previous U.S. EPA remedial efforts (**Figure 9a**).

According to MDEQ, re-handling of stamp sand in the Lake Linden area resulted in a large accumulation of stamp sand deposits at the head of Torch Lake (**Figure 9a**). This area was not part of the Torch Lake NPL Site and therefore not part of previous U.S. EPA remedial efforts and constitutes a new AOI based on the presence of stamp sand.

AOI Nos. 24, 25 and 26
SITE FEATURES AND XRF LOCATIONS
TORCH LAKE AREA ASSESSMENT
KEWEENAW PENINSULA, MICHIGAN
October 2007

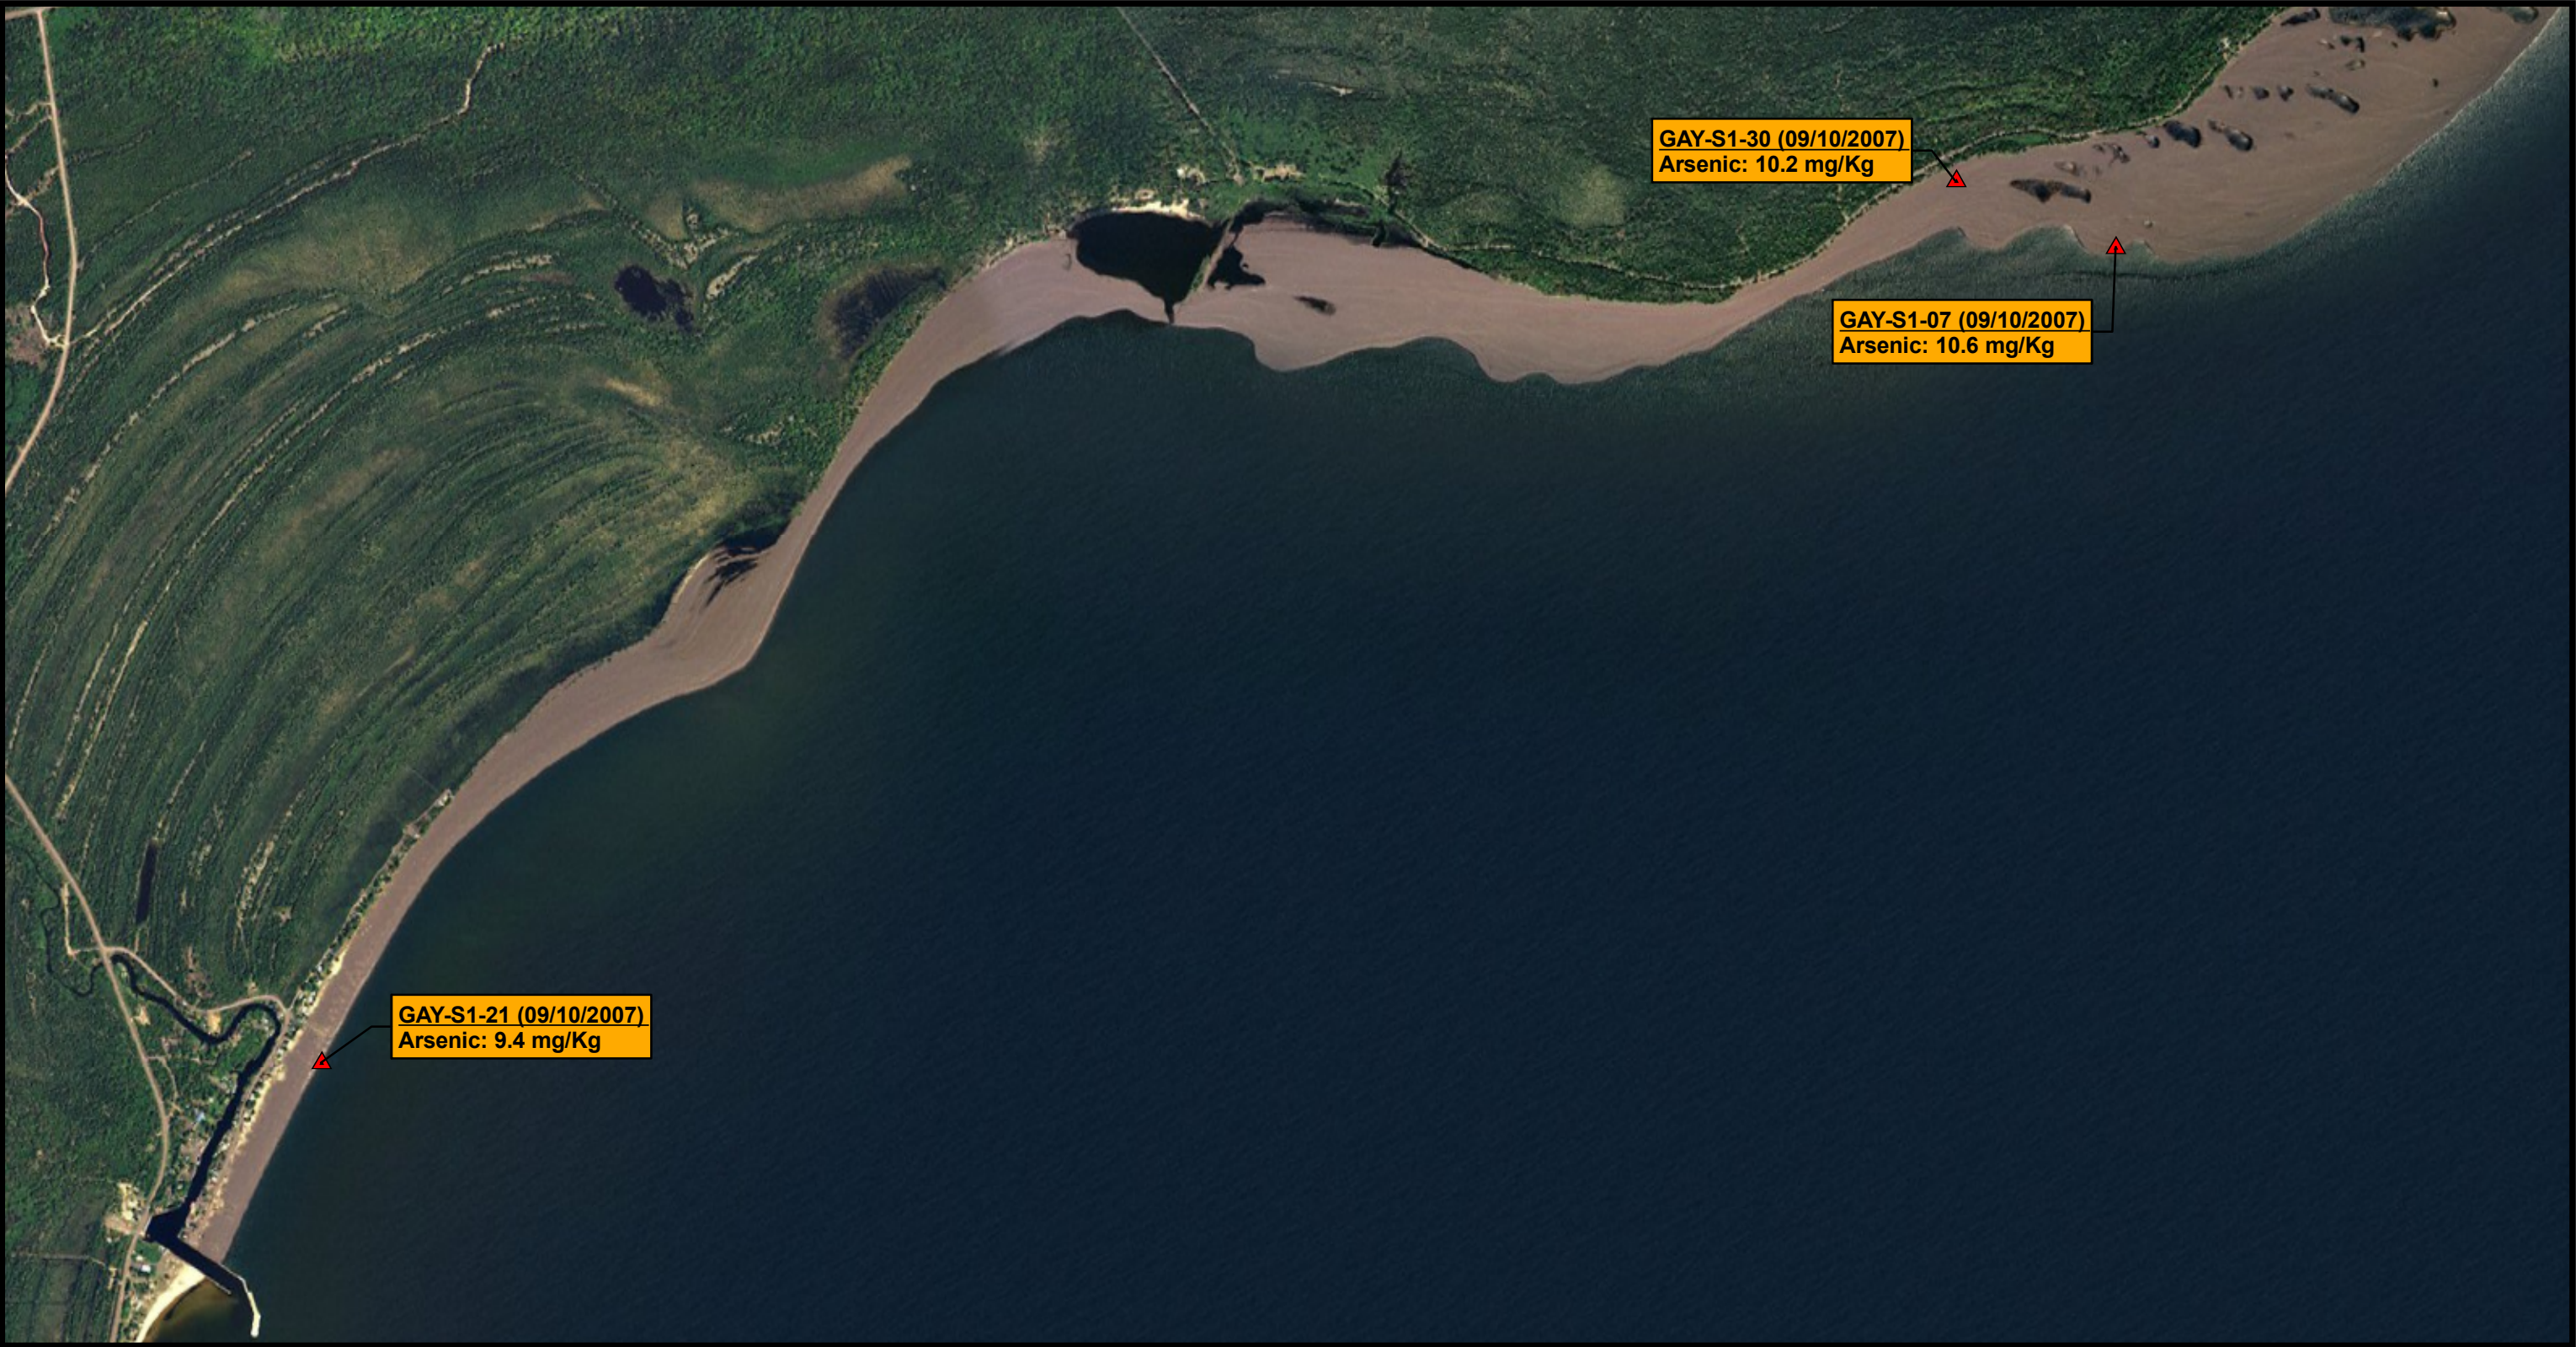
AOI No. 14 (ENTRANCE)
RDCC EXCEEDANCES IN SOIL
TORCH LAKE AREA ASSESSMENT
KEWEENAW PENINSULA, MICHIGAN
October 2007

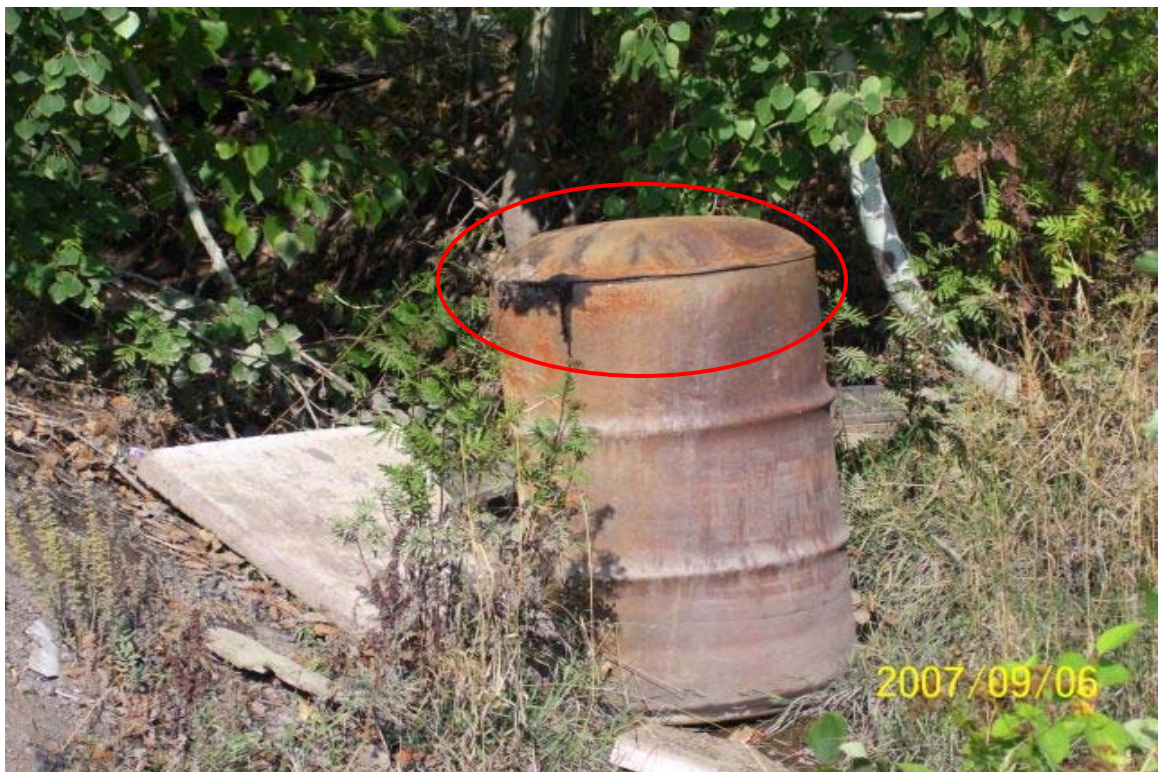
Photo Number: 2

WESTON START personnel performed the AA at the Copper Bowl on September 12, 2007. The Copper Bowl is a commercial bowling alley open to the public. The majority of the site is paved with asphalt. A bulged drum, discolored with black residue, was observed on the south edge of the property along the HRT. The drum may contain grease or other food-related waste. No XRF screening was performed at this location.

Subject: Bulged, leaking drum at Copper Bowl property (AOI 15)
